→ **Lead Paint Inspection Report**
Of

**125 S. Washington Street
Wadesboro, NC**

January 19, 2009

**Get The Lead Out, LLC
2121 Commonwealth Avenue, Suite 202
Charlotte, North Carolina 28205
704.376-3594**

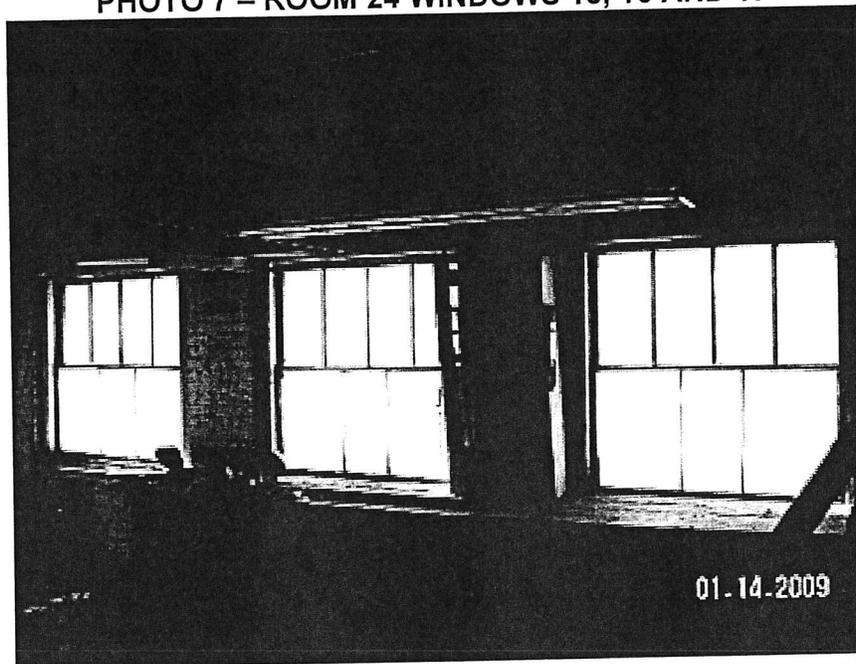
PHOTO 7 – ROOM 24 WINDOWS 15, 16 AND 17

Window 16	Deteriorated	Casing, Left	A	Wood	Room 24	White	Upper
Window 17	Deteriorated	Jamb	A	Wood	Room 24	White	Upper
